## **ENERGY ADVISORY COMMITTEE**

### **Loss of Electricity Supply Incident Affecting Parts of South London on 28 August 2003**

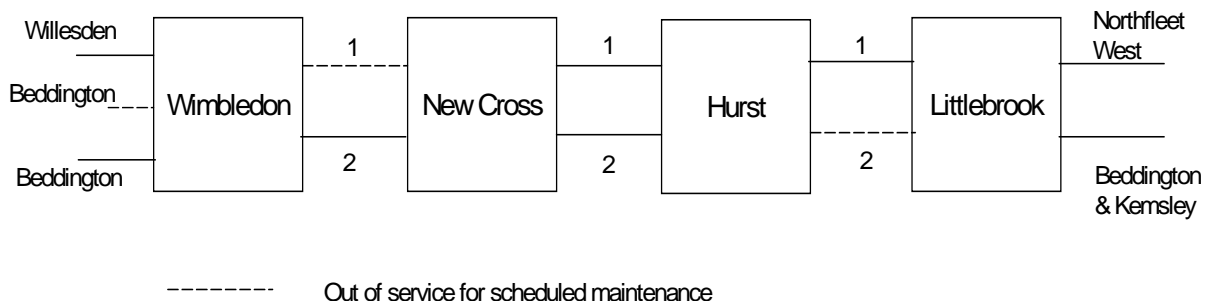
Related Transmission System of South London  
Figure 1

5. On 28 August 2003, scheduled maintenance was underway on transmission circuit 1 from Wimbledon substation to New Cross substation, and also on transmission circuit 2 from Littlebrook substation to Hurst substation (see Figure 1). This level of maintenance is not uncommon during the summer months, when demand for electricity is generally lower. The arrangements for the transmission system to accommodate the said maintenance activities had been agreed well in advance with all parties concerned during July 2002. EDF Energy had confirmed that it could arrange its distribution system to securely accommodate the outage of these transmission circuits throughout the maintenance period.

This switching sequence required the temporary switching off of transmission circuit 1 from Littlebrook substation to Hurst substation. This enabled a safe shutdown of the transformer which had suffered the alarm, but left only a single transmission circuit from Wimbledon substation to feed both New Cross and Hurst substations.

7. The switching sequence to remove the transformer began at 18:20, disconnecting Hurst substation completely from Littlebrook substation. Unexpectedly, a few seconds after the switching, the automatic protection equipment on transmission circuit 2 from Wimbledon substation to New Cross substation operated, interpreting the changes in power flow due to the switching as a fault on the circuit. This resulted in the disconnection of New Cross substation, Hurst substation and part of Wimbledon substation from the rest of the transmission system, causing the loss of supply. 724 MW of power supplies were lost, amounting to around 20% of total London supplies at that time.
